Manhole Inspection Summary

Manhole # S23KK_027MH

Insp Date: **9/28/07 11:19 AM**

Location Address: **2525 PENNSYLVANIA AVE**

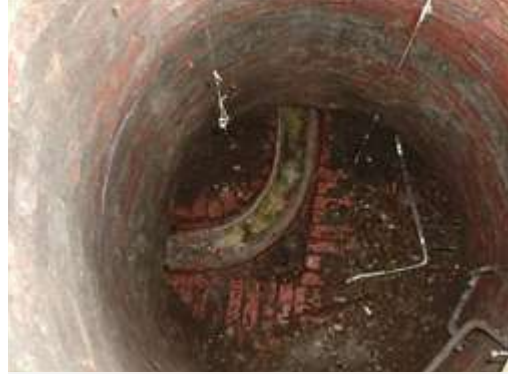
Top View

Evidence of surcharge - Bench debris.
Channel debris.

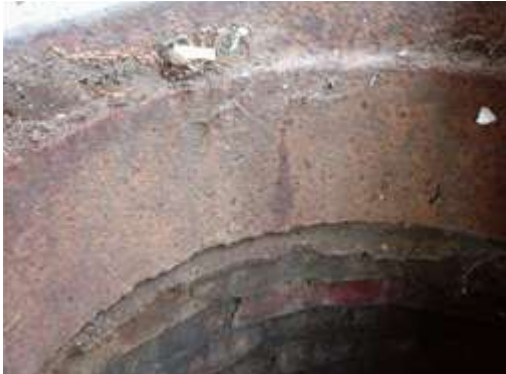
Defect

Frame leaks. Adjustment deterioration
and infiltration.

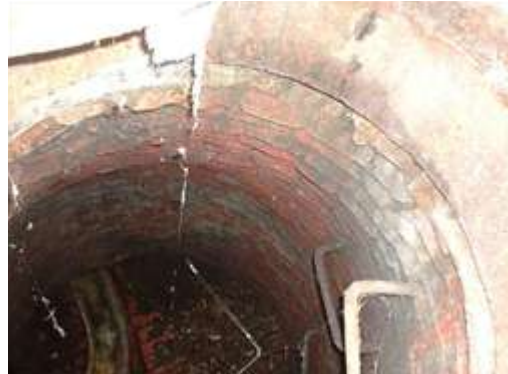
Defect

Frame leaks. Adjustment deterioration
and infiltration. Corbel and Barrel
infiltration. Corroded steps.

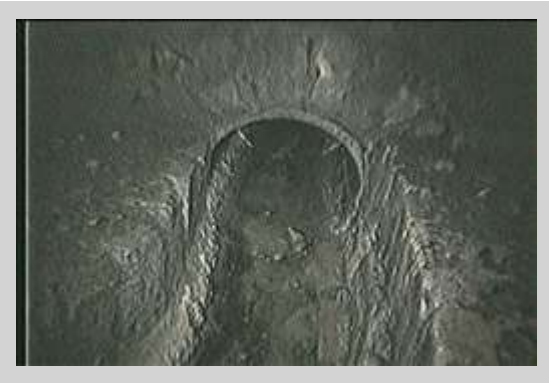
8 in. Circular Gravity Sewer Pipe Out @ 12 O'Clock

Deposits: ☐ None ☐ Mud ☐ Sludge ☐ Debris ☒ **Grease**

Silt Depth: **0** (in.) Deposits Extent: **Light**

Infiltration: **Evidence** Pipe Seal Cond: **Unknown**

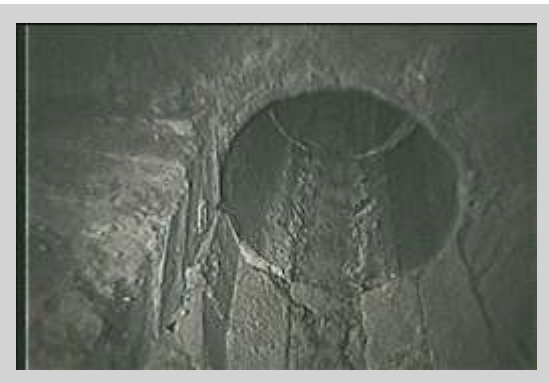
8 in. Circular Gravity Sewer Pipe In @ 9 O'Clock

Channel deterioration.

Deposits: ☐ None ☐ Mud ☐ Sludge ☐ Debris ☒ **Grease**

Infiltration: **None** Pipe Seal Cond: **Cracked**
